BOARD OF PUBLIC WORKS OF THE COUNTY OF KENT

April 27, 1983

RE: Response to Your Letter Dated March 30, 1983

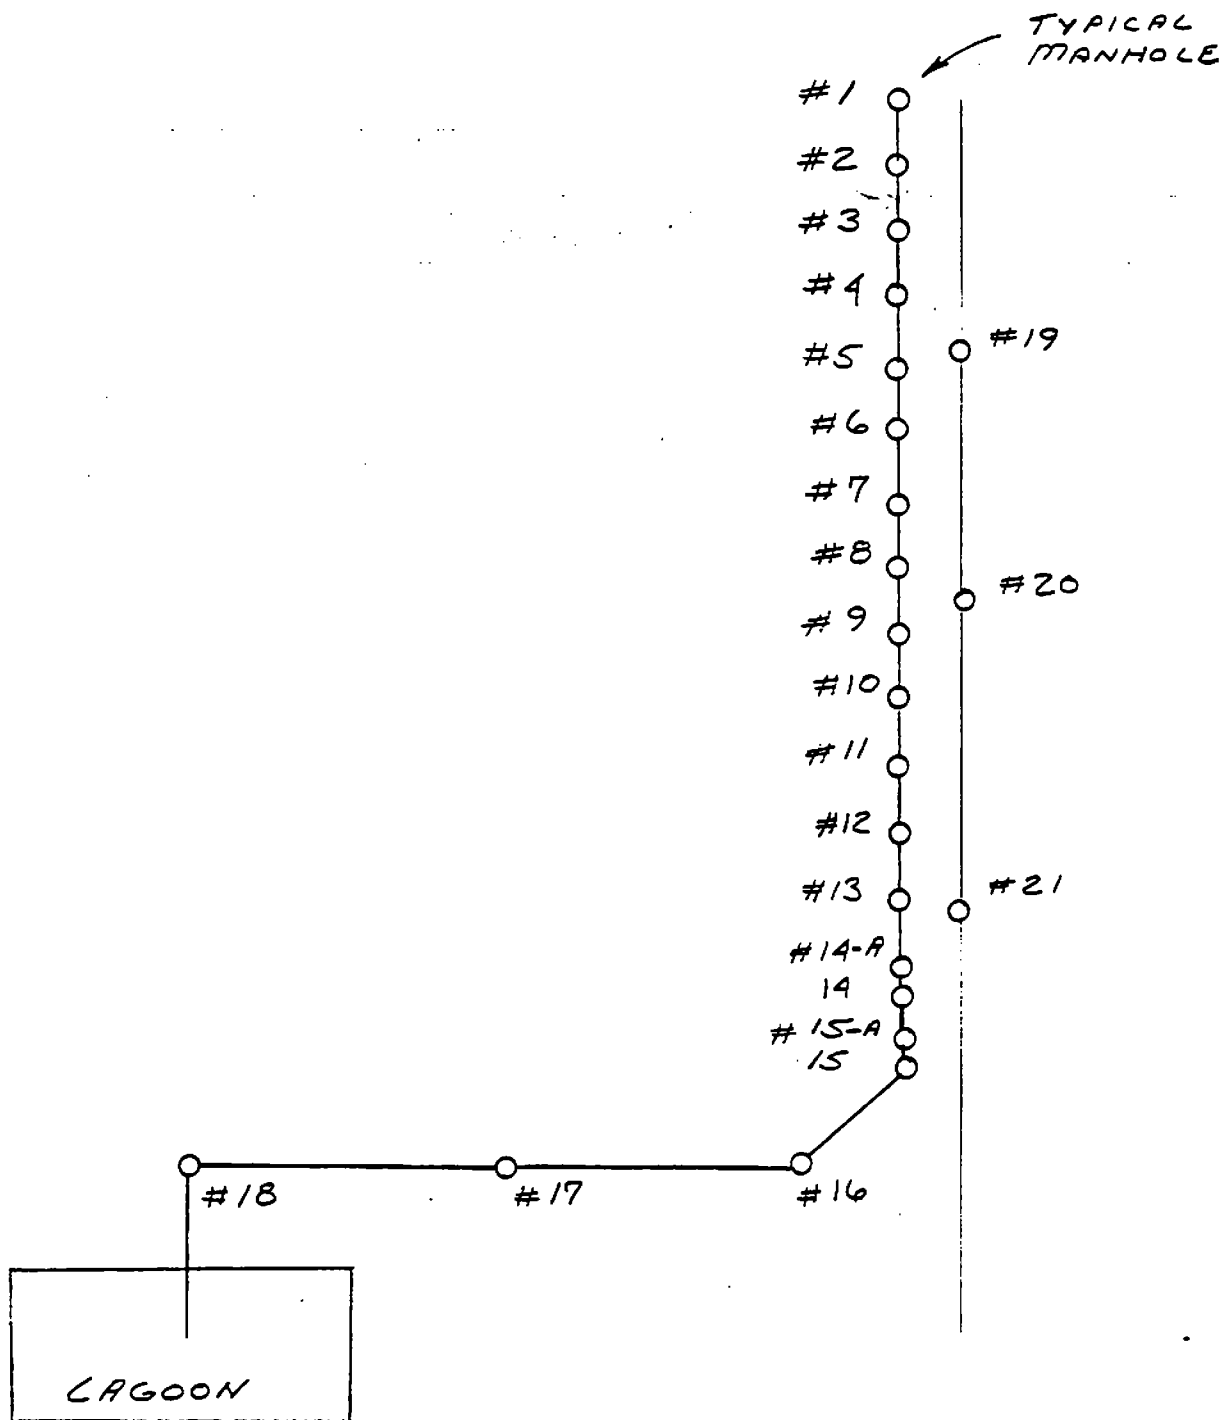
FIGURE ONE

Since our last meeting, the D.P.W. staff disassembled some of the leachate collection system and did an inspection of all manholes. Our findings indicated that there is a constraint in the 8" gravity line between manholes number 2 and 3 (see attached sketch). There is approximately 12 feet of standing liquid in manholes number 1 and 2. All other manholes appear to be functioning normally. I have already contracted the services of a sewer cleaning contractor to remove the constraint and clean and perform television inspection of 1,500 feet of the 8" gravity sewer. This represents all the sewer that is directly underneath the active landfill area. The contractor is expected to complete the work within 60 days. Approval to do the work was given at the April 27, 1983, meeting of the Board of Public Works.

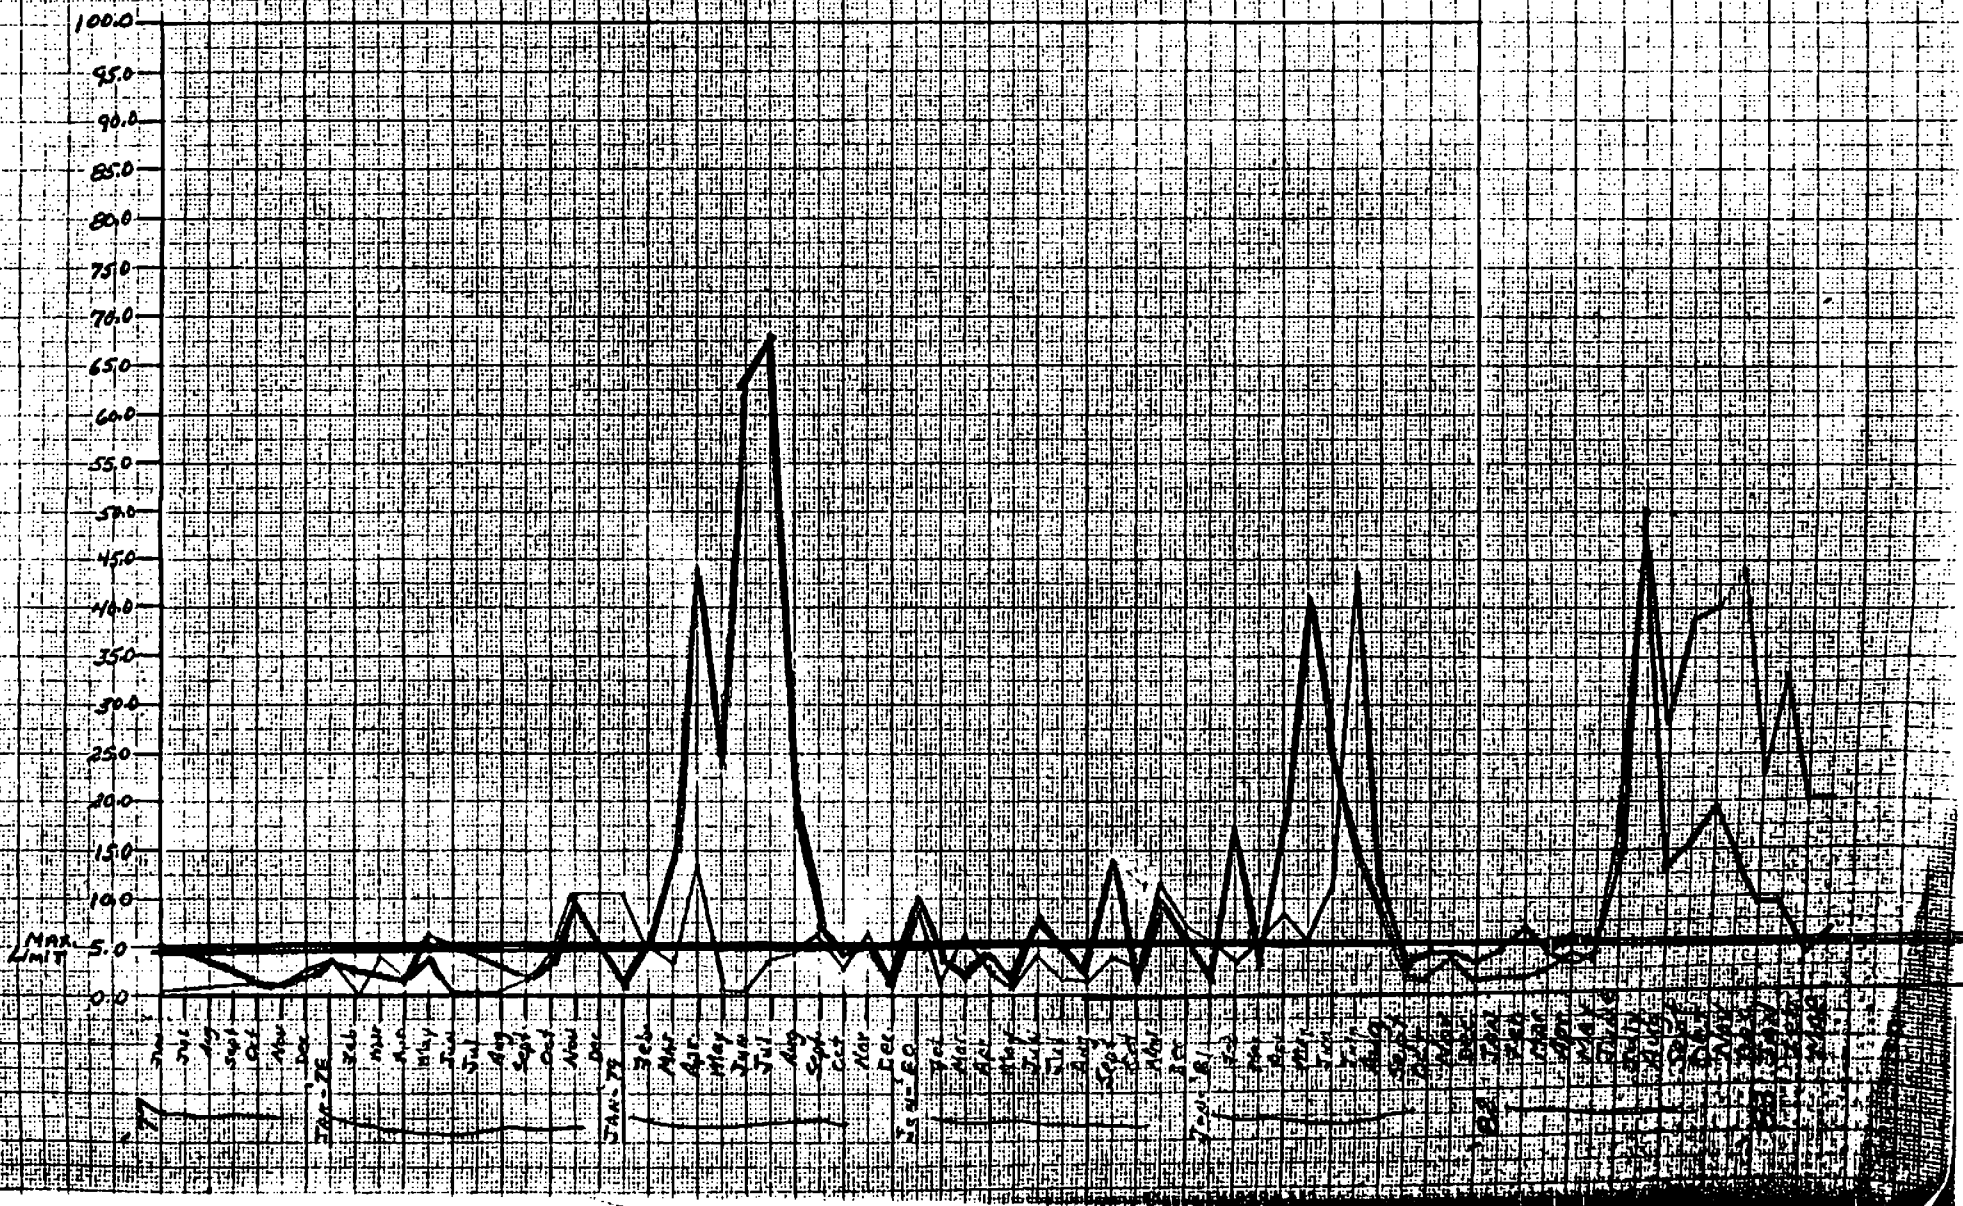
As you may recall, a similar but more severe situation like this occurred in the summer of 1979. I have attached a graph showing BOD concentrations during this time. This graph clearly indicates the affect which cleaning the sewer had on the system, and should help confirm our belief that once the system is returned to gravity flow the problem will be solved. I do not feel that any other remedial action as described in your letter should take place at this time. However, I would like to respond to the proposed actions you itemized.
